YOUR INSPECTION REPORT

123 Dreamhome St
Guelph, ON

Wednesday, August 5, 2009

RE: Report No. 1006
123 Dreamhome St
Guelph, ON
N1G 0B#

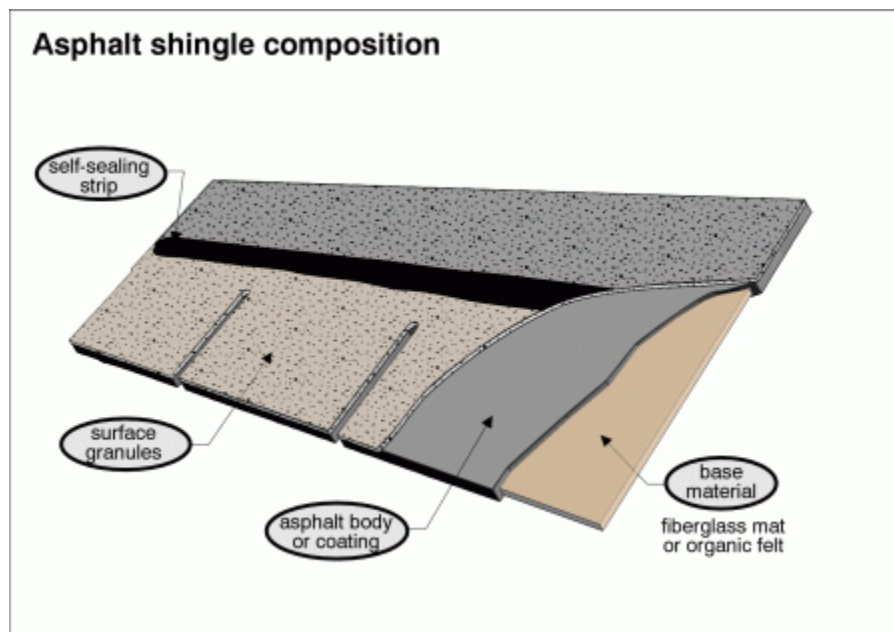
Sloped roofing \ Asphalt shingles

Condition: • [Granule loss](#)

Implication(s): Chance of water damage to contents, finishes and/or structure

Location: Various Roof

Task: Monitor

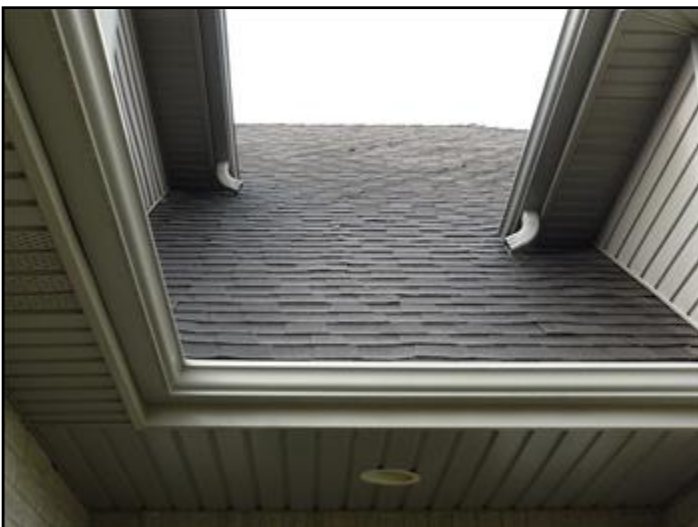
2.

Roof drainage \ Gutters

Condition: • [Discharging onto roof](#)

Implication(s): Material deterioration

Location: Front Roof

Task: Correct

Time: Less than 1 year

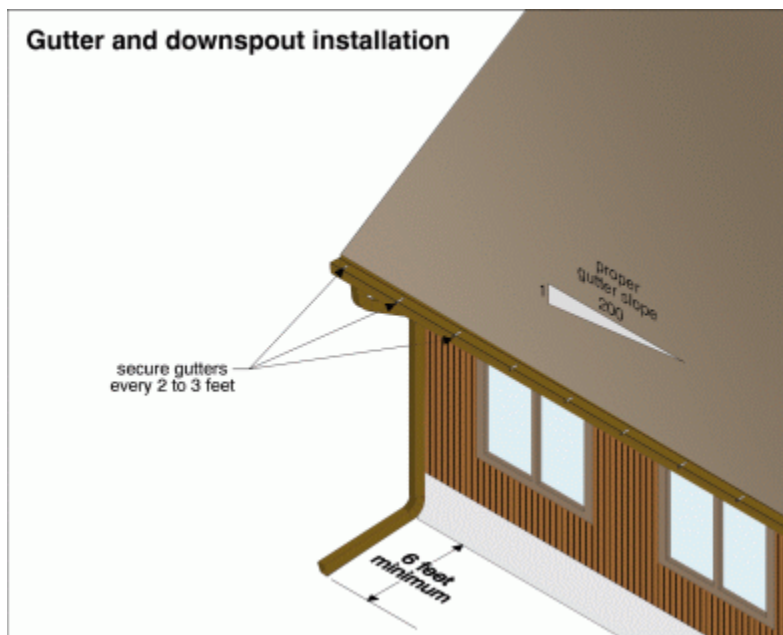
Roof drainage \ Downspouts

Condition: • [Downspouts end too close to building](#)

Implication(s): Chance of water damage to contents, finishes and/or structure

Location: Front

Task: Correct

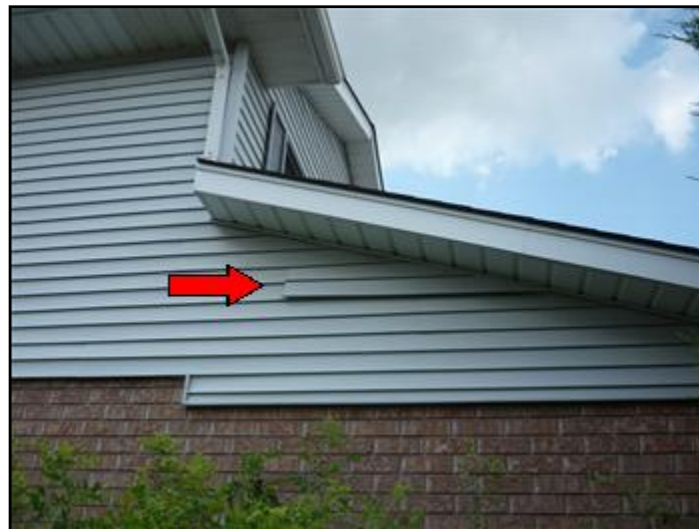
6.

Walls \ Vinyl siding

Condition: • [Loose or missing pieces](#)

Implication(s): Cosmetic defects | Chance of water damage to contents, finishes and/or structure

Location: Left Side Exterior Wall

Task: Repair or replace

Time: Immediate

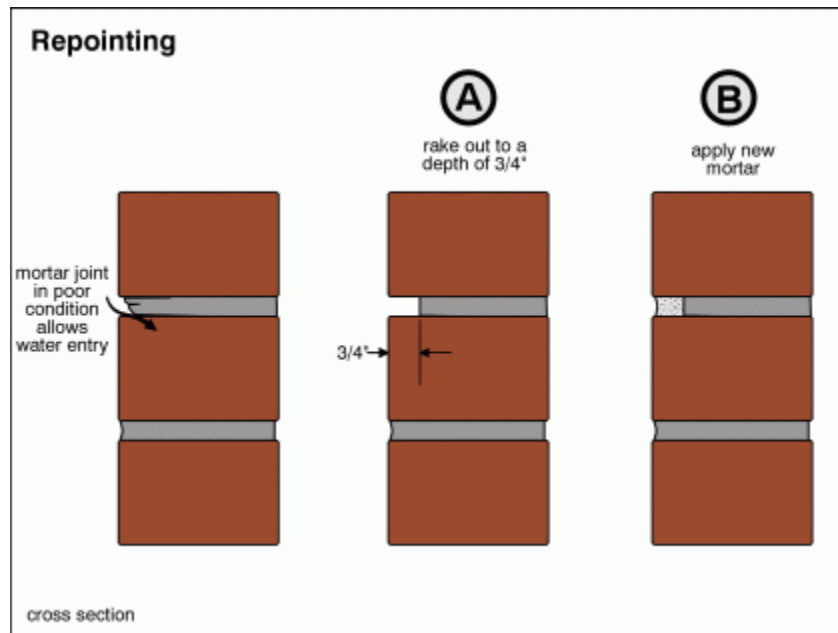
Walls \ Brick, stone and concrete

Condition: • [Mortar deterioration](#)

Implication(s): Chance of water entering house | Weakened structure | Chance of structural movement

Location: Left Side Exterior Wall

Task: Repair

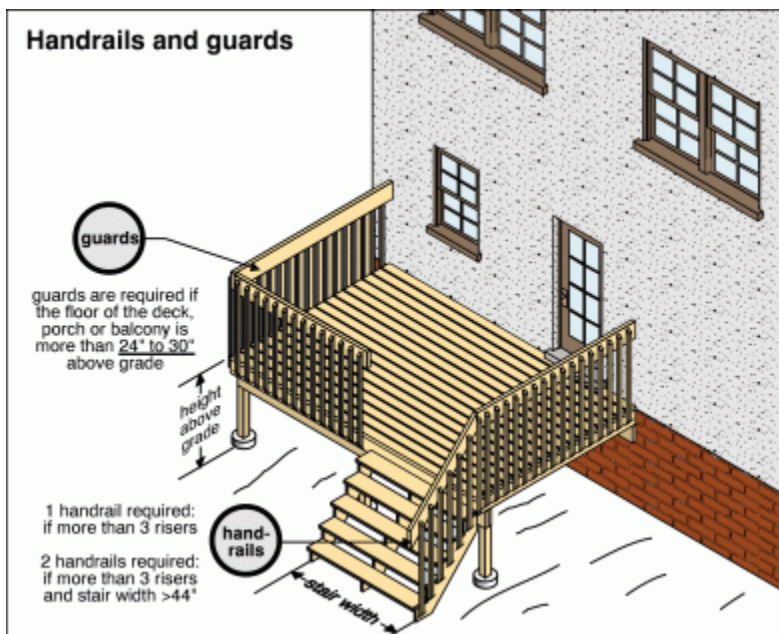
Porches, decks, steps, patios and balconies \ Handrails and guards

Condition: • [Missing](#)

Implication(s): Fall hazard

Location: Rear Exterior Deck

Task: Correct

Time: Immediate

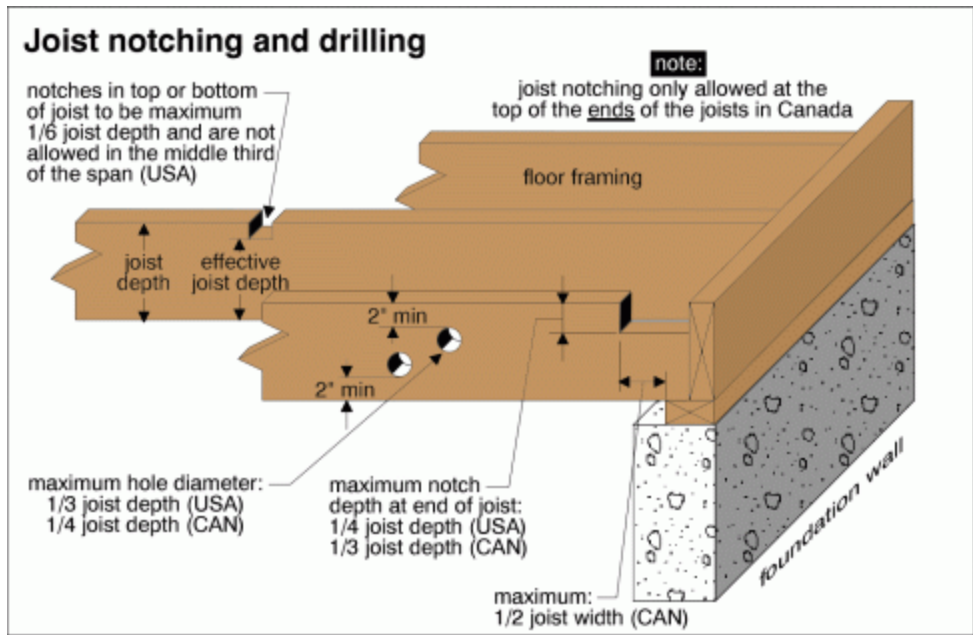
Floors \ Joists

Condition: • [Notches or holes](#)

Implication(s): Weakened structure

Location: Left Side Basement

Task: Repair or replace

Time: Immediate

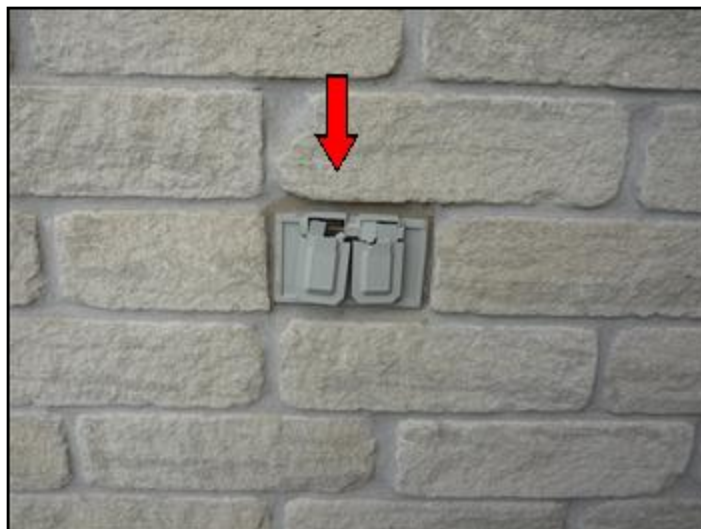
10.

Distribution system \ Outlets

Condition: • [Damage](#)

Implication(s): Electric shock | Fire hazard

Location: Rear

Task: Replace

Time: Immediate

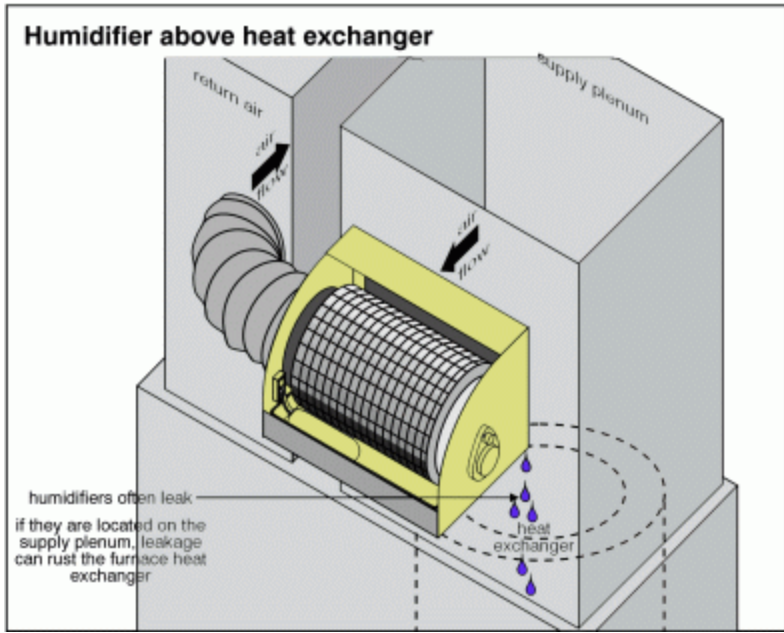
Gas furnace \ Humidifier

Condition: • [Leak](#)

Implication(s): Chance of water damage to contents, finishes and/or structure | Damage to equipment

Location: Basement Furnace Room

Task: Repair or replace

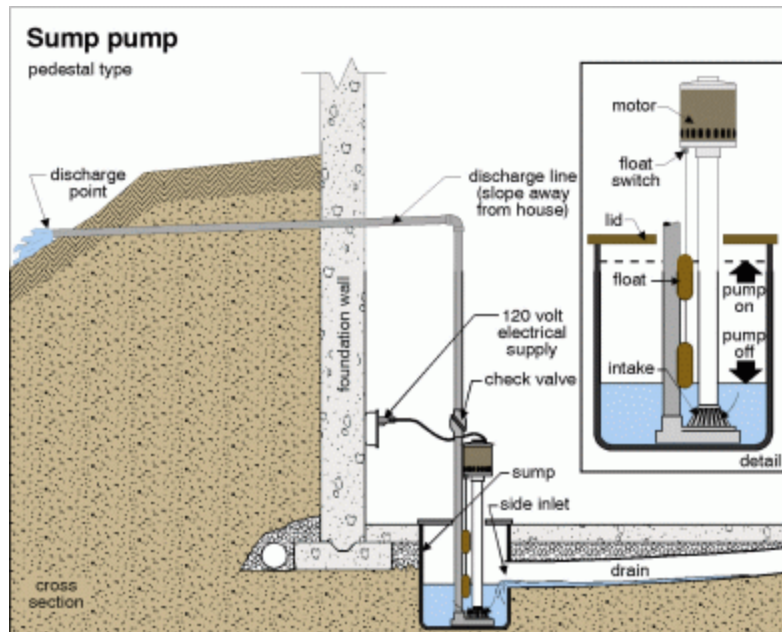
Waste plumbing \ Sump pump

Condition: • [Discharge pipe problems](#)

Implication(s): Chance of water damage to contents, finishes and/or structure

Location: Rear

Note: Sump pump discharges at the foundation

Task: Correct
