YOUR INSPECTION REPORT

123 Dreamhome St
Guelph, ON

Wednesday, August 5, 2009

RE: Report No. 1006
123 Dreamhome St
Guelph, ON
N1G 0B#

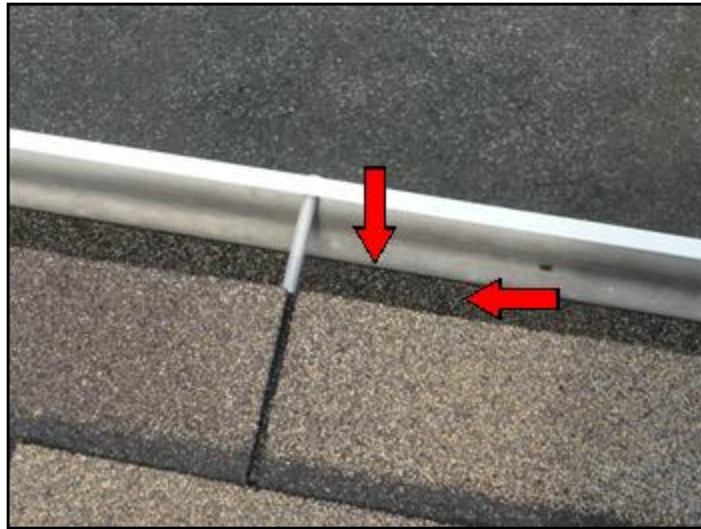
1.

Condition: • [Granule loss](#)

Implication(s): Chance of water damage to contents, finishes and/or structure

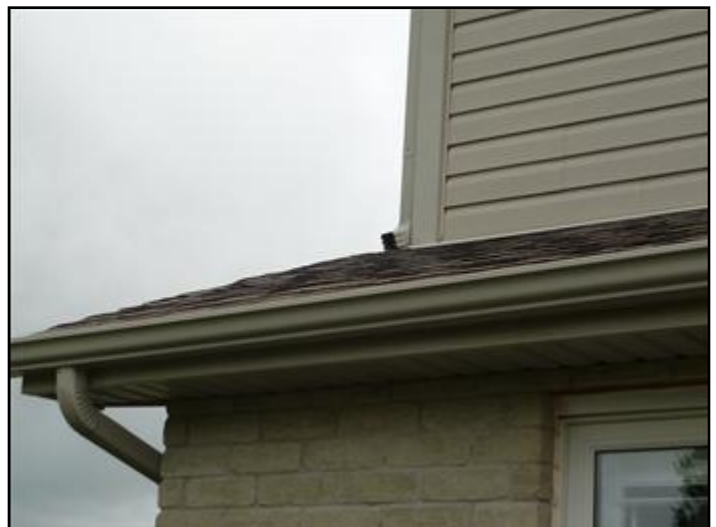
3.

Condition: • [Downspouts end too close to building](#)

Implication(s): Chance of water damage to contents, finishes and/or structure

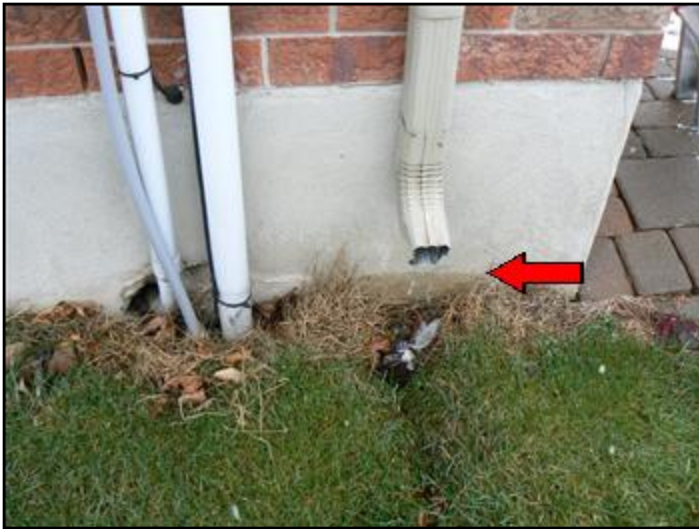
4.

Condition: • [Loose or missing pieces](#)

Implication(s): Cosmetic defects | Chance of water damage to contents, finishes and/or structure

Task: Repair or replace
